About Terminal Connection “Fretting”

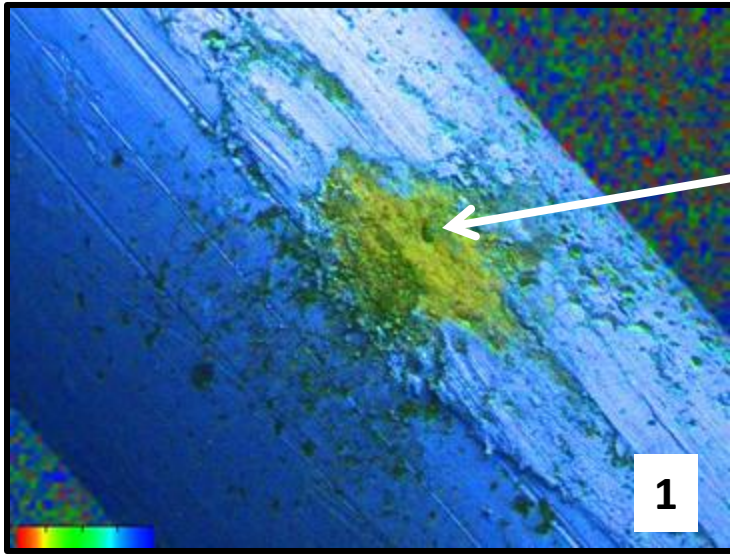
Fretting corrosion is a buildup of insulating oxidized debris (nonconductive material) caused by micro motion between two contact surfaces. (Fig 1)

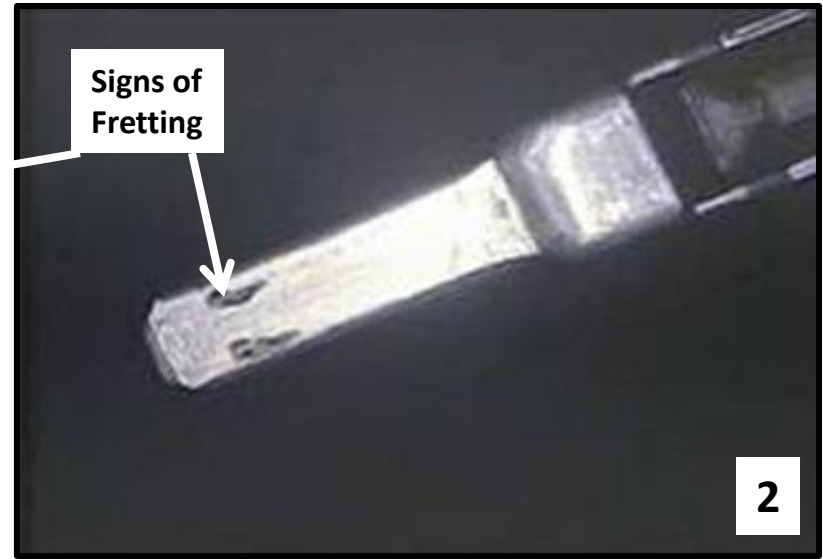
Fretting usually appears as: small, dark smudges on electrical terminals, or smudges at the locations of electrical contact (Fig. 2). In less severe cases, it may require a magnifying glass to identify a fretting condition.
