# About Terminal Connection “Fretting”

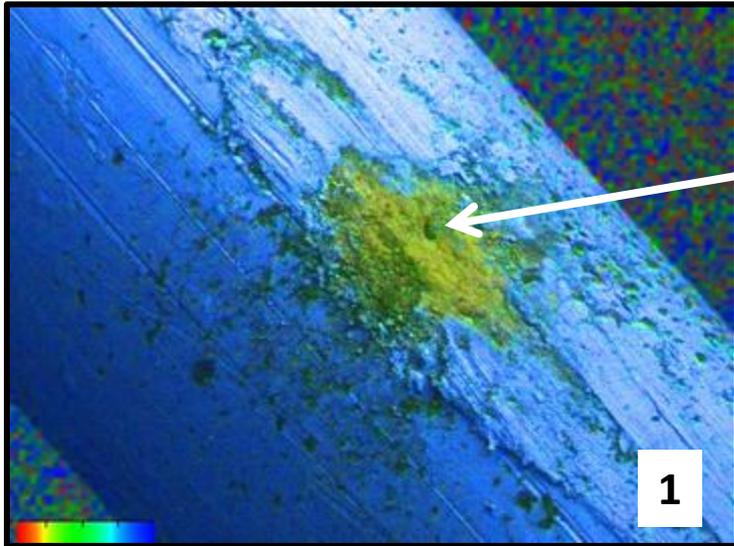
Fretting corrosion is a buildup of insulating oxidized debris (nonconductive material) caused by micro motion between two contact surfaces. (Fig 1)

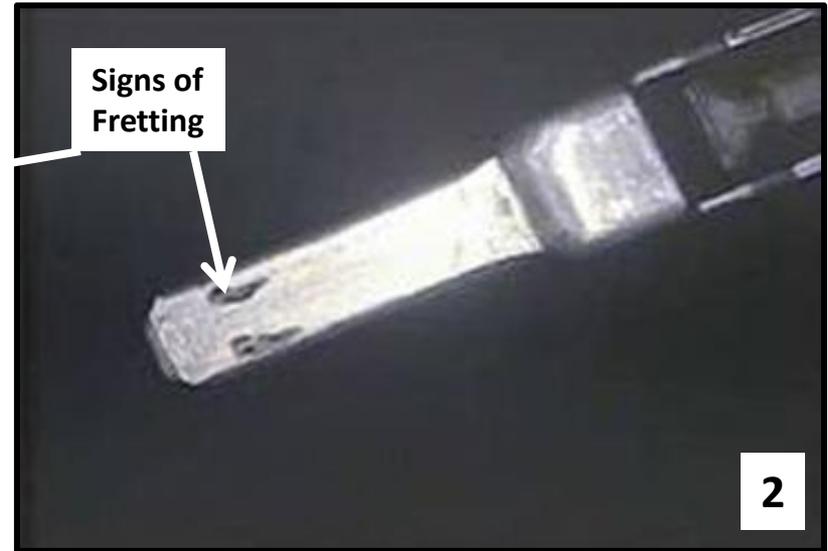
Fretting usually appears as: small, dark smudges on electrical terminals, or smudges at the locations of electrical contact (Fig. 2). In less severe cases, it may require a magnifying glass to identify a fretting condition.

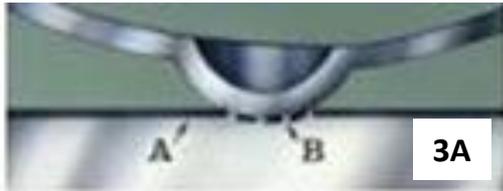
A. Tin - clean (free of any corrosion) (Fig. 3, A)

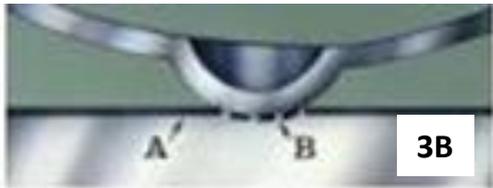
B. A connection is made through the cracks in the tin-oxide layer, making a stable connection. (Fig. 3, B)

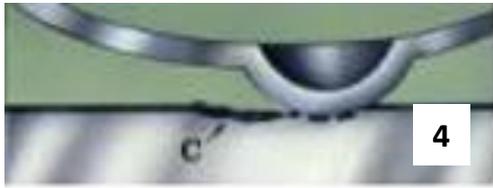
C. When the terminal vibrates or moves a section of the clean tin is exposed to the air and it quickly forms an insulating tin-oxide film. (Fig. 4)
